# XTreme

## Firmware Revisions

Document - English 2.00

This document keeps track of firmware revisions for the MGL Avionics Stratomaster XTreme instrument range.

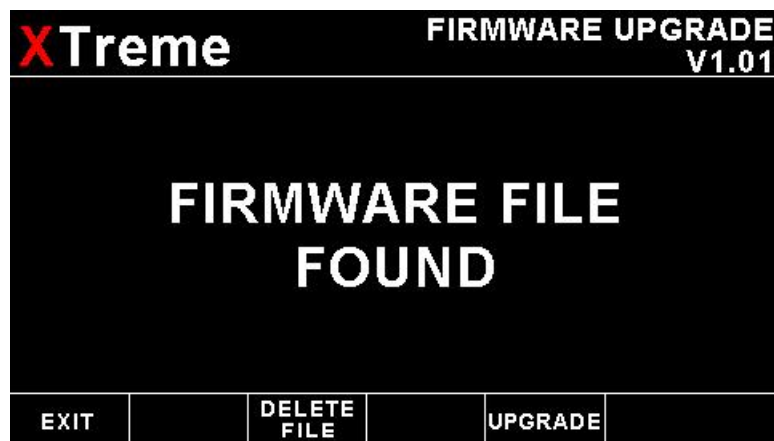
The XTreme's firmware can be upgraded in the field to the latest version via the SD card. This will keep your XTreme up to date with bug fixes, new features etc. The name of the file must be called XT2EFIS.FW (EFIS file) and XT2EMS.FW (EMS file) and it must reside in the root directory. When the XTreme powers up it will first look at the SD card to see whether the file exists, if it does then it will prompt the user to upgrade the firmware. Use the soft keys at the bottom to select whether to upgrade to the new firmware or to exit the firmware upgrade feature. If the file does not exist, then the firmware upgrade function is bypassed and the XTremes main program is executed. Please check <http://www.mglavionics.co.za/XTreme.html> regularly for the latest firmware releases.

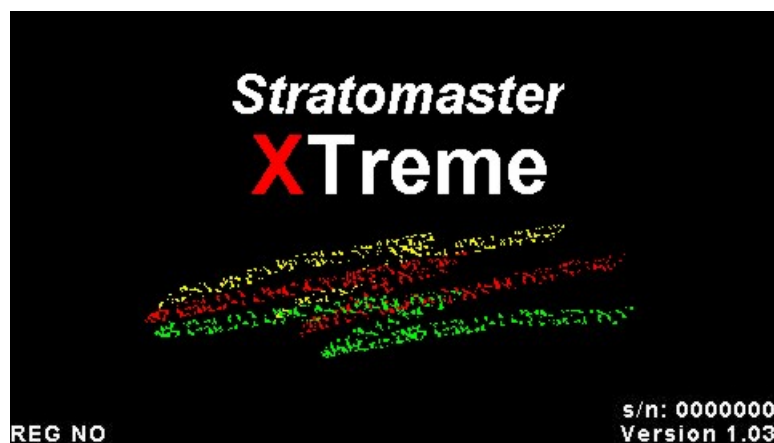
The revision number is displayed on the instrument's startup screen as follows.
